Evaluation Report

Bee Model 7410 Combine Loss Monitor

ALBERTA
FARM
MACHINERY
RESEARCH
CENTRE

PRAIRIE AGRICULTURAL MACHINERY INSTITUTE

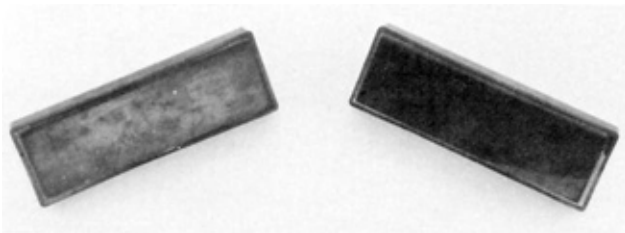
FIGURE 2. Sensors.

Sensor Installation: The BEE 7410 is supplied with two 156 x 56 mm (6.1 x 2.2 in) pad-type sensors (FIGURE 2) for mounting at the rear of the straw walkers and shoe.

The shoe sensor may be mounted behind the shoe or beneath the shoe behind the tailings auger. It was found that a sensor, mounted behind the shoe, gave more positive sampling of losses than did the one beneath the shoe.

The walker sensor may be mounted in the bottom of a closed straw walker or on the grain pan beneath an open straw walker. It was found that a sensor could also be mounted behind the straw walker, however, flying objects from the straw chopper could damage this sensor.
